**Flood Control Project Maintenance
Levee Inspections**

Fall 2018 Levee Maintenance Deficiency Summary Report

Levee Inspection Report By Mile - Fall 2018

Sutter Maintenance Yard Maintenance Area 0007

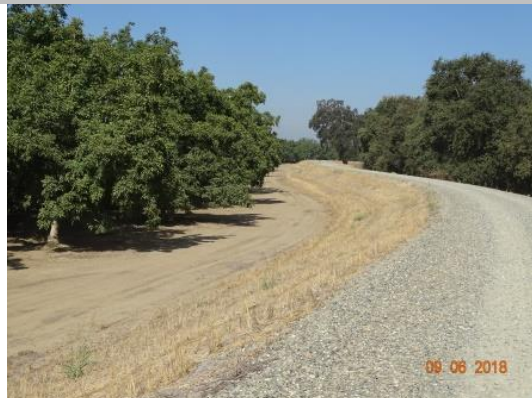
Photo 1 of 1 : FA_2018_MA0007_200_11_20181002_00026.jpg

LM Start	0.01	Rating **	A	Issue No.	11
LM End	11.87	Issue Type +	Ma	Location *	LS
Category	Earthen Levee			GPS Latitude/Longitude	
				Start	End
Item	Vegetation			39.311145°	39.439263°
				-121.637616°	-121.641856°
DWR ID	DWR_MA0007_01_f_2018_11				
Comment Code					
V1 : Control annual grass and weeds on the levee slopes and easements.					
Inspector Comment					
The annual vegetation is well maintained, Fall 2018.

View looking upstream landside at the well maintained vegetation, Fall 2018.

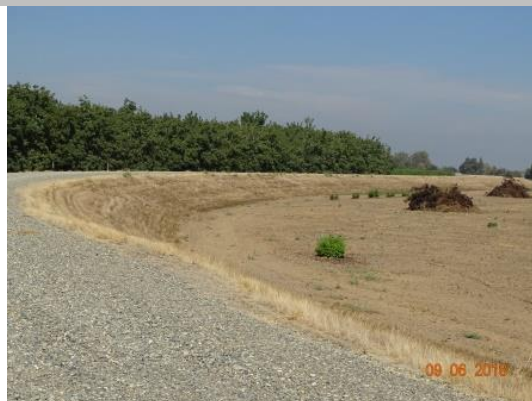
Photo 1 of 1 : FA_2018_MA0007_200_12_20181002_00027.jpg

LM Start	0.01	Rating **	A	Issue No.	12
LM End	11.87	Issue Type +	Ma	Location *	WS
Category	Earthen Levee			GPS Latitude/Longitude	
				Start	End
Item	Vegetation			39.311148 °	39.439263 °
				-121.637615 °	-121.641856 °
DWR ID	DWR_MA0007_01_f_2018_12				
Comment Code					
V1 : Control annual grass and weeds on the levee slopes and easements.					
Inspector Comment					
The annual vegetation is well maintained, Fall 2018.

View looking upstream waterside at the well maintained vegetation, Fall 2018.

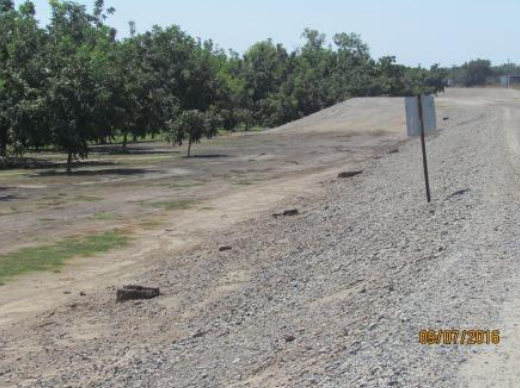
Photo 1 of 1 : FA_2018_MA0007_200_69_20180906_00010.jpg

View looking downstream of several tree stumps at the levee toe on the waterside, still exist.

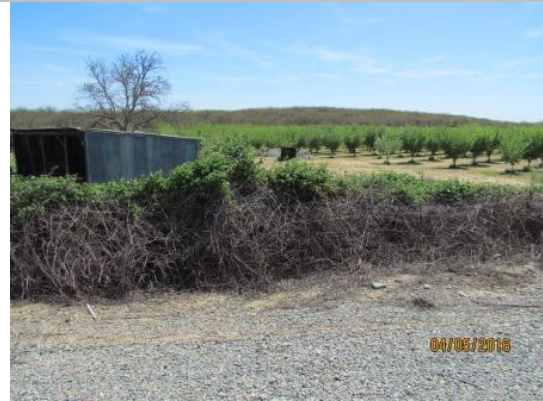
Photo 1 of 1 : FA_2018_MA0007_200_67_20180906_00007.jpg

LM Start	0.92	Rating **	A/W	Issue No.	67
LM End	0.92	Issue Type +	Ma	Location *	LS
Category	Earthen Levee			GPS Latitude/Longitude	
				Start	End
Item	Vegetation			39.323118°	39.323118°
				-121.632205°	-121.632205°
DWR ID	DWR_MA0007_01_s_2016_67				
Comment Code					
V2 : Remove the wild growth other than native grasses from the levee slopes.					
Inspector Comment					
The black berry bushes are continued to be sprayed and maintained at the levee toe, Fall 2018.

View of landside toe vegetation looking downstream.

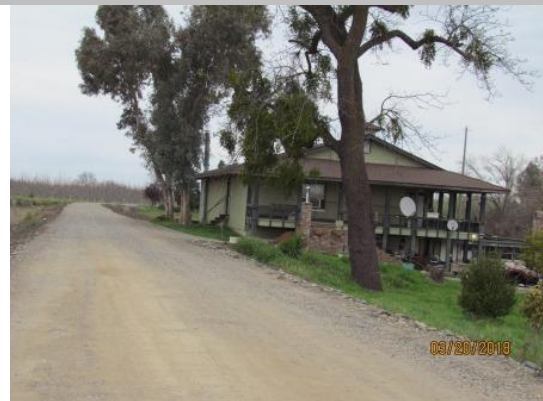
Photo 1 of 1 : FA_2018_MA0007_200_33_20180906_00001.jpg

LM Start	1.21	Rating **	U	Issue No.	33
LM End	1.21	Issue Type +	En	Location *	WS
Category	Earthen Levee			GPS Latitude/Longitude	
				Start	End
Item	Encroachments			39.327187°	39.327187°
				-121.632395°	-121.632395°
DWR ID	DWR_MA0007_01_s_2012_33				
Comment Code					
BU : Building					
Inspector Comment					
No permit found for this residence.

Levee mile 1.21. This is a photo of the building on the waterside slope.

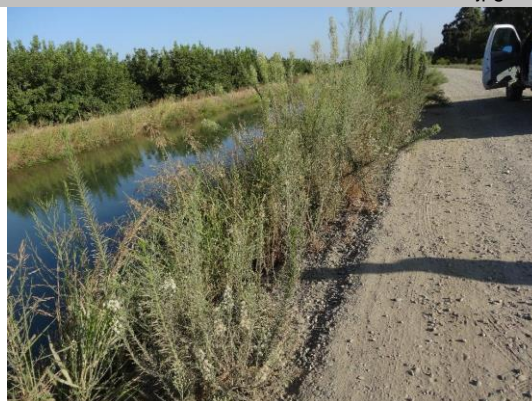
Photo 1 of 3 : UCIP_FA_2018_52408_77326.jpg

Comment Code					
Inspector Comment					
FS_ID:52408 DS_ID:16928 EP_NO: N/A Repair Type: Non-Urgent Crossing Status: Found UCIP Comments: 08/09/2017 Crossing is still present, no modifications were made to this crossing. Crossing still appears to be abandoned and not in use, recommend contacting owner to determine status of crossing. This pipe was not part of the Feather River West Levee Improvements, Project D. Pipe is located outside the project limits. Project Improvements began at Station (Sta) 1765+00 (MA0007 about LM 1.73) to Sta 2303+50 (ST0005 about LM 1.23), refer to record drawings for the Feather River West Levee Improvement Plans Station 1765+00 to 2368+26, Project D details. (DWR UCIP - O. Magana)08/02/2017 Unknown if crossing was modified, not shown in record drawings. (DWR UCIP - O. Magana) 5/16/2016 Feather River West Levee Improvement Project--Levee currently under construction.6/10/2015 Same as last inspection.12/29/2014 Same as last inspection.5/19/2014 Same as last inspection.11/6/2013 Same as last inspection.5/13/2013 SBFCA project recommends replacing in accordance with title 23.5/10/2013 Same as last inspection. LS scour behind structure needs to be repaired.10/31/2012 crossing appears abandoned, slide gate is missing on landward side; wood frame remains on LS; scour hole present on LS, 3 feet by 3 feet, near wood frame. (DWR UCIP - O. Magana) FIELD_STRUCT_DESC: *ABANDONED* 12-inch corrugated metal drainage pipe through the levee, 8.2 feet below the crown. Slide gate on the landside (LS) is no longer present. Concrete "U" headwall at the waterside (WS) toe. Irrigation ditch located on the LS. [Additional Reference(s): DWR Levee Log, 2005] FS Date: 8/9/2017

LS view: tall vegetation along LS slope.

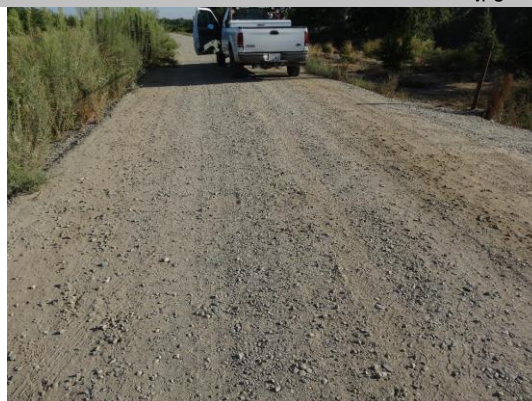
Photo 2 of 3 : UCIP_FA_2018_52408_77327.jpg

Comment Code						
Inspector Comment						
FS_ID:52408 DS_ID:16928 EP_NO: N/A Repair Type: Non-Urgent Crossing Status: Found UCIP Comments: 08/09/2017 Crossing is still present, no modifications were made to this crossing. Crossing still appears to be abandoned and not in use, recommend contacting owner to determine status of crossing. This pipe was not part of the Feather River West Levee Improvements, Project D. Pipe is located outside the project limits. Project Improvements began at Station (Sta) 1765+00 (MA0007 about LM 1.73) to Sta 2303+50 (ST0005 about LM 1.23), refer to record drawings for the Feather River West Levee Improvement Plans Station 1765+00 to 2368+26, Project D details. (DWR UCIP - O. Magana)08/02/2017 Unknown if crossing was modified, not shown in record drawings. (DWR UCIP - O. Magana) 5/16/2016 Feather River West Levee Improvement Project--Levee currently under construction.6/10/2015 Same as last inspection.12/29/2014 Same as last inspection.5/19/2014 Same as last inspection.11/6/2013 Same as last inspection.5/13/2013 SBFCA project recommends replacing in accordance with title 23.5/10/2013 Same as last inspection. LS scour behind structure needs to be repaired.10/31/2012 crossing appears abandoned, slide gate is missing on landward side; wood frame remains on LS; scour hole present on LS, 3 feet by 3 feet, near wood frame. (DWR UCIP - O. Magana) FIELD_STRUCT_DESC: *ABANDONED* 12-inch corrugated metal drainage pipe through the levee, 8.2 feet below the crown. Slide gate on the landside (LS) is no longer present. Concrete "U" headwall at the waterside (WS) toe. Irrigation ditch located on the LS. [Additional Reference(s): DWR Levee Log, 2005] FS Date: 8/9/2017

Overview of levee at crossing looking upstream.

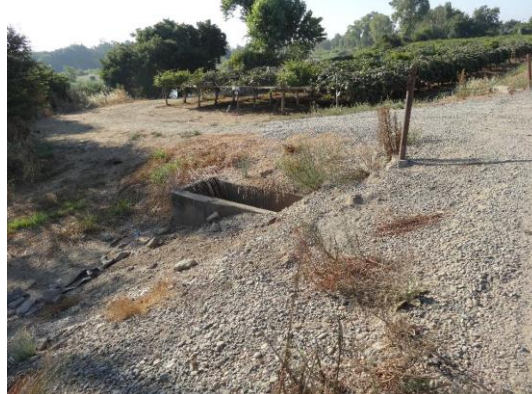
Photo 3 of 3 : UCIP_FA_2018_52408_77325.jpg

Comment Code						
Inspector Comment						
FS_ID:52408 DS_ID:16928 EP_NO: N/A Repair Type: Non-Urgent Crossing Status: Found UCIP Comments: 08/09/2017 Crossing is still present, no modifications were made to this crossing. Crossing still appears to be abandoned and not in use, recommend contacting owner to determine status of crossing. This pipe was not part of the Feather River West Levee Improvements, Project D. Pipe is located outside the project limits. Project Improvements began at Station (Sta) 1765+00 (MA0007 about LM 1.73) to Sta 2303+50 (ST0005 about LM 1.23), refer to record drawings for the Feather River West Levee Improvement Plans Station 1765+00 to 2368+26, Project D details. (DWR UCIP - O. Magana)08/02/2017 Unknown if crossing was modified, not shown in record drawings. (DWR UCIP - O. Magana) 5/16/2016 Feather River West Levee Improvement Project--Levee currently under construction.6/10/2015 Same as last inspection.12/29/2014 Same as last inspection.5/19/2014 Same as last inspection.11/6/2013 Same as last inspection.5/13/2013 SBFCA project recommends replacing in accordance with title 23.5/10/2013 Same as last inspection. LS scour behind structure needs to be repaired.10/31/2012 crossing appears abandoned, slide gate is missing on landward side; wood frame remains on LS; scour hole present on LS, 3 feet by 3 feet, near wood frame. (DWR UCIP - O. Magana) FIELD_STRUCT_DESC: *ABANDONED* 12-inch corrugated metal drainage pipe through the levee, 8.2 feet below the crown. Slide gate on the landside (LS) is no longer present. Concrete "U" headwall at the waterside (WS) toe. Irrigation ditch located on the LS. [Additional Reference(s): DWR Levee Log, 2005] FS Date: 8/9/2017

WS view: concrete box located on WS toe.

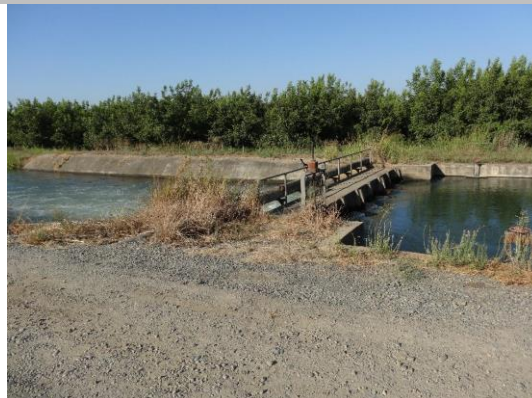
Photo 1 of 3 : UCIP_FA_2018_52386_77330.jpg

Comment Code					
Inspector Comment					
FS_ID:52386 DS_ID:20816 EP_NO: N/A Repair Type: Non-Urgent Crossing Status: Found UCIP Comments: 08/09/2017 It appears that this pipe is used to water the orchard located on the WS. Dense vegetation present along the WS slope, recommend clearing vegetation to allow for proper inspection of levee slope. No permit has been identified since 2012. (DWR UCIP - O. Magana)08/02/2017 After reviewing record drawings it appears this crossing has remained. This pipe was not part of the Feather River West Levee Improvements, Project D. Pipe is located outside the project limits. Project Improvements began at Station (Sta) 1765+00 (MA0007 about LM 1.73) to Sta 2303+50 (ST0005 about LM 1.23), refer to record drawings for the Feather River West Levee Improvement Plans Station 1765+00 to 2368+26, Project D details. (DWR UCIP - O. Magana) 5/16/2016 Feather River West Levee Improvement Project--Levee currently under construction.6/10/2015 Crossing has been modified since last inspection. 3' black plastic pipe is now running through the metal pipe and the difference was capped and welded. 12/29/2014 Same as last inspection.5/19/2014 Same as last inspection.11/6/2013 Same as last inspection.5/13/2013 SBFCA project recommends removal. Permit number and owner in detailed report book.5/7/2013 Same as last inspection. Recommend finding owner.10/30/2012 Crossing was installed about 1 foot deep--need permit authorizing wrk. (DWR UCIP - O. Magana) FIELD_STRUCT_DESC: 12-inch steel irrigation pipe through the levee, 1 foot below the crown. Crossing on the landside (LS) is attached to a weir above ground. Siphon breaker located on the waterside (WS). No opening on the WS. No permit has been identified since crossing was field discovered in 2012. (Existing 12-inch steel irrigation pipe crossing remained during the Feather River West Levee Improvements, Project D). [Additional Reference(s): Sutter Butte Flood Control Agency (SBFCA) Feather River West Levee Project, Volume 4 of 6 (Project D) Feather River West Levee Improvement Plans Sta 1765+00 to 2368+26, 2016, Volume 4-SBFCA_Record_Drawings_Project D_2017.05.16.pdf, Drawing No. C-101]. FS Date: 8/9/2017

LS view: pipe visible along LS canal.

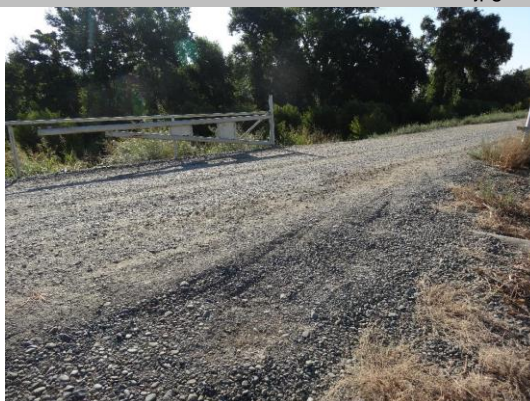
Photo 2 of 3 : UCIP_FA_2018_52386_77331.jpg

Comment Code						
Inspector Comment						
FS_ID:52386 DS_ID:20816 EP_NO: N/A Repair Type: Non-Urgent Crossing Status: Found UCIP Comments: 08/09/2017 It appears that this pipe is used to water the orchard located on the WS. Dense vegetation present along the WS slope, recommend clearing vegetation to allow for proper inspection of levee slope. No permit has been identified since 2012. (DWR UCIP - O. Magana)08/02/2017 After reviewing record drawings it appears this crossing has remained. This pipe was not part of the Feather River West Levee Improvements, Project D. Pipe is located outside the project limits. Project Improvements began at Station (Sta) 1765+00 (MA0007 about LM 1.73) to Sta 2303+50 (ST0005 about LM 1.23), refer to record drawings for the Feather River West Levee Improvement Plans Station 1765+00 to 2368+26, Project D details. (DWR UCIP - O. Magana) 5/16/2016 Feather River West Levee Improvement Project--Levee currently under construction.6/10/2015 Crossing has been modified since last inspection. 3' black plastic pipe is now running through the metal pipe and the difference was capped and welded. 12/29/2014 Same as last inspection.5/19/2014 Same as last inspection.11/6/2013 Same as last inspection.5/13/2013 SBFCA project recommends removal. Permit number and owner in detailed report book.5/7/2013 Same as last inspection. Recommend finding owner.10/30/2012 Crossing was installed about 1 foot deep--need permit authorizing wrk. (DWR UCIP - O. Magana) FIELD_STRUCT_DESC: 12-inch steel irrigation pipe through the levee, 1 foot below the crown. Crossing on the landside (LS) is attached to a weir above ground. Siphon breaker located on the waterside (WS). No opening on the WS. No permit has been identified since crossing was field discovered in 2012. (Existing 12-inch steel irrigation pipe crossing remained during the Feather River West Levee Improvements, Project D). [Additional Reference(s): Sutter Butte Flood Control Agency (SBFCA) Feather River West Levee Project, Volume 4 of 6 (Project D) Feather River West Levee Improvement Plans Sta 1765+00 to 2368+26, 2016, Volume 4-SBFCA_Record_Drawings_Project D_2017.05.16.pdf, Drawing No. C-101]. FS Date: 8/9/2017

Overview of levee crown at crossing looking downstream.

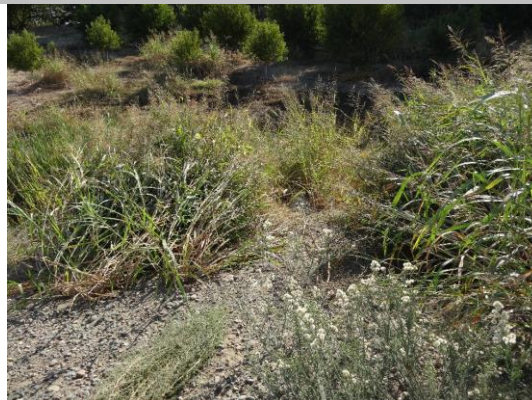
Photo 3 of 3 : UCIP_FA_2018_52386_77332.jpg

Comment Code						
Inspector Comment						
FS_ID:52386 DS_ID:20816 EP_NO: N/A Repair Type: Non-Urgent Crossing Status: Found UCIP Comments: 08/09/2017 It appears that this pipe is used to water the orchard located on the WS. Dense vegetation present along the WS slope, recommend clearing vegetation to allow for proper inspection of levee slope. No permit has been idenfied since 2012. (DWR UCIP - O. Magana)08/02/2017 After reviewing record drawings it appears this crossing has remained. This pipe was not part of the Feather River West Levee Improvements, Project D. Pipe is located outside the project limits. Project Improvements began at Station (Sta) 1765+00 (MA0007 about LM 1.73) to Sta 2303+50 (ST0005 about LM 1.23), refer to record drawings for the Feather River West Levee Improvement Plans Station 1765+00 to 2368+26, Project D details. (DWR UCIP - O. Magana) 5/16/2016 Feather River West Levee Improvement Project--Levee currently under construction.6/10/2015 Crossing has been modified since last inspection. 3' black plastic pipe is now running through the metal pipe and the difference was capped and welded. 12/29/2014 Same as last inspection.5/19/2014 Same as last inspection.11/6/2013 Same as last inspection.5/13/2013 SBFCA project recommends removal. Permit number and owner in detailed report book.5/7/2013 Same as last inspection. Recommend finding owner.10/30/2012 Crossing was installed about 1 foot deep--need permit authorizing wrk. (DWR UCIP - O. Magana) FIELD_STRUCT_DESC: 12-inch steel irrigation pipe through the levee, 1 foot below the crown. Crossing on the landside (LS) is attached to a weir above ground. Siphon breaker located on the waterside (WS). No opening on the WS. No permit has been identified since crossing was field discovered in 2012. (Existing 12-inch steel irrigation pipe crossing remained during the Feather River West Levee Improvements, Project D). [Additional Reference(s): Sutter Butte Flood Control Agency (SBFCA) Feather River West Levee Project, Volume 4 of 6 (Project D) Feather River West Levee Improvement Plans Sta 1765+00 to 2368+26, 2016, Volume 4-SBFCA_Record_Drawings_Project D_2017.05.16.pdf, Drawing No. C-101]. FS Date: 8/9/2017

WS view: dense vegetation along WS slope.

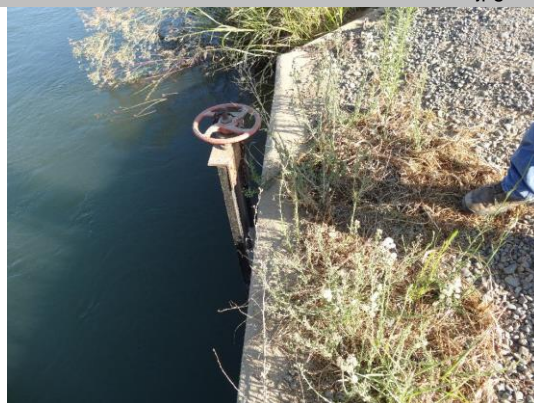
Photo 1 of 3 : UCIP_FA_2018_52387_77335.jpg

UCIP Comments: 08/09/2017 Crossing is still present, unable to confirm is crossing is still in use. Recommend contacting owner to determine status, remove dense vegetation blocking outlet, and to obtain permit authorizing crossing. (DWR UCIP - O. Magana)

5/16/2016 Feather River West Levee Improvement Project--Levee currently under construction.6/10/2015 WS headwall is still damaged and no repairs were made to this pipe. Looks like the SBFCA project skipped over this area so pipe was not replaced as it was listed to be.12/29/2014 Same as last inspection.5/19/2014 Same as last inspection.11/6/2013 Same as last inspection.5/13/2013 SBFCA project recommends replacing with accordance to title 23.5/7/2013 Same as last inspection, however exposed rebar on WS headwall does not impede structure performance.10/31/2012 WS headwall rebar exposed. This crossing was listed in the USACE Periodic Inspections as ID# USACE_CESPK_MA07_2010_a_0051 however, no issue listed. (DWR UCIP - O. Magana)

LS view: screw gate and concrete headwall visible on LS.

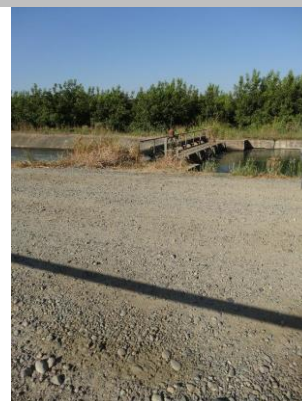
Photo 2 of 3 : UCIP_FA_2018_52387_77336.jpg

Comment Code						
Inspector Comment						
FS_ID:52387 DS_ID:16927 EP_NO: N/A Repair Type: Non-Urgent Crossing Status: Found UCIP Comments: 08/09/2017 Crossing is still present, unable to confirm is crossing is still in use. Recommend contacting owner to determine status, remove dense vegetation blocking outlet, and to obtain permit authorizing crossing. (DWR UCIP - O. Magana) 08/02/2017 After reviewing record drawings it appears this crossing has remained. This pipe was not part of the Feather River West Levee Improvements, Project D. Pipe is located outside the project limits. Project Improvements began at Station (Sta) 1765+00 (MA0007 about LM 1.73) to Sta 2303+50 (ST0005 about LM 1.23), refer to record drawings for the Feather River West Levee Improvement Plans Station 1765+00 to 2368+26, Project D details. (DWR UCIP - O. Magana) 5/16/2016 Feather River West Levee Improvement Project--Levee currently under construction.6/10/2015 WS headwall is still damaged and no repairs were made to this pipe. Looks like the SBFCA project skipped over this area so pipe was not replaced as it was listed to be.12/29/2014 Same as last inspection.5/19/2014 Same as last inspection.11/6/2013 Same as last inspection.5/13/2013 SBFCA project recommends replacing with accordance to title 23.5/7/2013 Same as last inspection, however exposed rebar on WS headwall does not impede structure performance.10/31/2012 WS headwall rebar exposed. This crossing was listed in the USACE Periodic Inspections as ID# USACE_CESPK_MA07_2010_a_0051 however, no issue listed. (DWR UCIP - O. Magana) FIELD_STRUCT_DESC: 10-inch polyvinyl chloride (PVC) pipe encased in a 12-inch corrugated metal irrigation pipe through the levee, 7 feet below the crown. Concrete U-shaped headwall at the waterside (WS) toe. Concrete headwall and slide gate on the landside (LS). Concrete weir in the canal. (Existing 10-inch PVC pipe and 12-inch corrugated metal [concrete indicated in record drawings] irrigation pipe crossing remained during the Feather River West Levee Improvements, Project D). [Additional Reference(s): DWR Levee Log, 2005. Sutter Butte Flood Control Agency (SBFCA) Feather River West Levee Project, Volume 4 of 6 (Project D) Feather River West Levee Improvement Plans Sta 1765+00 to 2368+26, 2016, Volume 4-SBFCA_Record_Drawings_Project D_2017.05.16.pdf, Drawing No. C-101]. FS Date: 8/9/2017

Overview of levee crown at crossing.

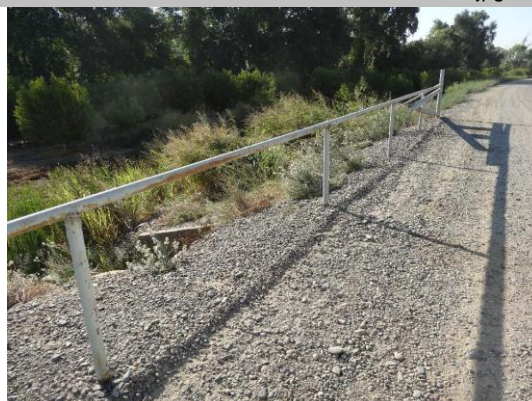
Photo 3 of 3 : UCIP_FA_2018_52387_77337.jpg

FS_ID:52387
DS_ID:16927
EP_NO: N/A
Repair Type: Non-Urgent
Crossing Status: Found
UCIP Comments: 08/09/2017 Crossing is still present, unable to confirm is crossing is still in use. Recommend contacting owner to determine status, remove dense vegetation blocking outlet, and to obtain permit authorizing crossing. (DWR UCIP - O. Magana)
08/02/2017 After reviewing record drawings it appears this crossing has remained. This pipe was not part of the Feather River West Levee Improvements, Project D. Pipe is located outside the project limits. Project Improvements began at Station (Sta) 1765+00 (MA0007 about LM 1.73) to Sta 2303+50 (ST0005 about LM 1.23), refer to record drawings for the Feather River West Levee Improvement Plans Station 1765+00 to 2368+26, Project D details. (DWR UCIP - O. Magana)
5/16/2016 Feather River West Levee Improvement Project--Levee currently under construction.6/10/2015 WS headwall is still damaged and no repairs were made to this pipe. Looks like the SBFCA project skipped over this area so pipe was not replaced as it was listed to be.12/29/2014 Same as last inspection.5/19/2014 Same as last inspection.11/6/2013 Same as last inspection.5/13/2013 SBFCA project recommends replacing with accordance to title 23.5/7/2013 Same as last inspection, however exposed rebar on WS headwall does not impede structure performance.10/31/2012 WS headwall rebar exposed. This crossing was listed in the USACE Periodic Inspections as ID# USACE_CESPK_MA07_2010_a_0051 however, no issue listed. (DWR UCIP - O. Magana)

FIELD_STRUCT_DESC: 10-inch polyvinyl chloride (PVC) pipe encased in a 12-inch corrugated metal irrigation pipe through the levee, 7 feet below the crown. Concrete U-shaped headwall at the waterside (WS) toe. Concrete headwall and slide gate on the landside (LS). Concrete weir in the canal. (Existing 10-inch PVC pipe and 12-inch corrugated metal [concrete indicated in record drawings] irrigation pipe crossing remained during the Feather River West Levee Improvements, Project D). [Additional Reference(s): DWR Levee Log, 2005. Sutter Butte Flood Control Agency (SBFCA) Feather River West Levee Project, Volume 4 of 6 (Project D) Feather River West Levee Improvement Plans Sta 1765+00 to 2368+26, 2016, Volume 4-SBFCA_Record_Drawings_Project_D_2017.05.16.pdf, Drawing No. C-101].
FS Date: 8/9/2017

WS view: guardrail along the WS slope and concrete headwall visible on WS.

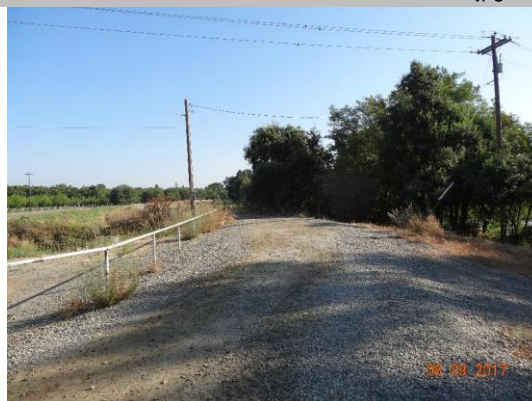
Photo 1 of 3 : UCIP_FA_2018_52390_77346.jpg

UCIP Comments: 08/09/2017 Dual 60-inch pipes are still present--no modifications appear to have been made to this structure. No permit or owner has been identified. Need to contact owner to notify of safety issue regarding the missing covers for CMP riser. (DWR UCIP - O. Magana)08/02/2017 After reviewing record drawings it appears this crossing has remained. Project Improvements begin at Station (Sta) 1765+00 (MA0007 about LM 1.73) to Sta 2303+50 (ST0005 about LM 1.23), refer to record drawings for the Feather River West Levee Improvement Plans Station 1765+00 to 2368+26, Project D details. MA0007 project details include NO CUTOFF WALL from Sta 1765+00 (MA0007 about LM 1.73) to 1815+00 (MA0007 about LM 2.64) and LEVEE DEGRADE AND RECONSTRUCTION WITH CUT OFF WALL from Sta 1817+00 (MA0007 about LM 2.69) to Sta 2289+00, Sta 2287+00 to Sta 2290+00 (MA0007 about LM 11.60). (DWR UCIP - O. Magana)

5/16/2016 Feather River West Levee Improvement Project--Levee currently under construction.6/10/2015 Debris still present in risers and pipes were not replaced with the SBFC project.12/29/2014 Same as last inspection.5/19/2014 Same as last inspection.11/6/2013 Same as last inspection.5/13/2013 SBFC project recommends replacing in accordance with title 23.5/7/2013 Same debris issue as last inspection. Recommend repairing top cover to prevent falls. Wheel to open gate chained and locked so could not verify gate operation.10/31/2012 Debris inside riser could prevent slide gate from closing. This crossing was listed in the USACE Periodic Inspections as ID# USACE_CESPK_MA07_2010_a_0060 however, no issues noted. (DWR UCIP - O. Magana)

Overview of levee crown looking upstream towards crossings.

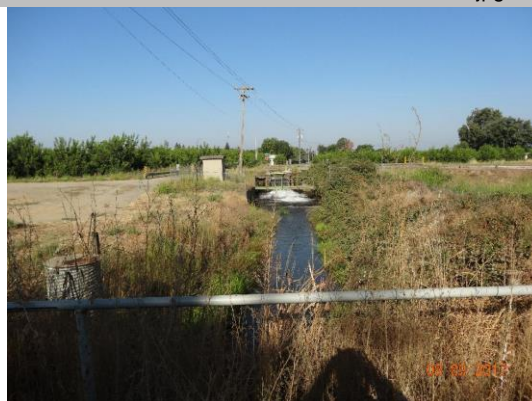
Photo 3 of 3 : UCIP_FA_2018_52390_77342.jpg

UCIP Comments: 08/09/2017 Dual 60-inch pipes are still present--no modifications appear to have been made to this structure. No permit or owner has been identified. Need to contact owner to notify of safety issue regarding the missing covers for CMP riser. (DWR UCIP - O. Magana)08/02/2017 After reviewing record drawings it appears this crossing has remained. Project Improvements begin at Station (Sta) 1765+00 (MA0007 about LM 1.73) to Sta 2303+50 (ST0005 about LM 1.23), refer to record drawings for the Feather River West Levee Improvement Plans Station 1765+00 to 2368+26, Project D details. MA0007 project details include NO CUTOFF WALL from Sta 1765+00 (MA0007 about LM 1.73) to 1815+00 (MA0007 about LM 2.64) and LEVEE DEGRADE AND RECONSTRUCTION WITH CUT OFF WALL from Sta 1817+00 (MA0007 about LM 2.69) to Sta 2289+00, Sta 2287+00 to Sta 2290+00 (MA0007 about LM 11.60). (DWR UCIP - O. Magana)

5/16/2016 Feather River West Levee Improvement Project--Levee currently under construction.6/10/2015 Debris still present in risers and pipes were not replaced with the SBFCA project.12/29/2014 Same as last inspection.5/19/2014 Same as last inspection.11/6/2013 Same as last inspection.5/13/2013 SBFCA project recommends replacing in accordance with title 23.5/7/2013 Same debris issue as last inspection. Recommend repairing top cover to prevent falls. Wheel to open gate chained and locked so could not verify gate operation.10/31/2012 Debris inside riser could prevent slide gate from closing. This crossing was listed in the USACE Periodic Inspections as ID# USACE_CESPK_MA07_2010_a_0060 however, no issues noted. (DWR UCIP - O. Magana)

LS view: view of canal looking west from crossing.

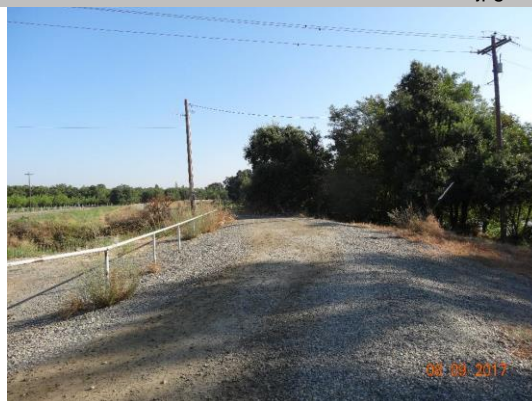
Photo 1 of 3 : UCIP_FA_2018_52389_77352.jpg

UCIP Comments: 08/09/2017 Dual 60-inch pipes are still present--no modifications appear to have been made to this structure. No permit or owner has been identified. Need to contact owner to notify of safety issue regarding the missing covers for CMP riser. (DWR UCIP - O. Magana)08/02/2017 After reviewing record drawings it appears this crossing has remained. Project Improvements begin at Station (Sta) 1765+00 (MA0007 about LM 1.73) to Sta 2303+50 (ST0005 about LM 1.23), refer to record drawings for the Feather River West Levee Improvement Plans Station 1765+00 to 2368+26, Project D details. MA0007 project details include NO CUTOFF WALL from Sta 1765+00 (MA0007 about LM 1.73) to 1815+00 (MA0007 about LM 2.64) and LEVEE DEGRADE AND RECONSTRUCTION WITH CUT OFF WALL from Sta 1817+00 (MA0007 about LM 2.69) to Sta 2289+00, Sta 2287+00 to Sta 2290+00 (MA0007 about LM 11.60). (DWR UCIP - O. Magana)

5/16/2016 Feather River West Levee Improvement Project--Levee currently under construction.6/10/2015 Debris still present inside riser and pipe was not replaced with the SBFCA project.12/29/2014 Same as last inspection.5/19/2014 Same as last inspection.11/6/2013 Same as last inspection.5/13/2013 SBFCA project recommends replacing in accordance with title 23.5/7/2013 Same as last inspection. Recommend constructing cover to prevent falls. Wheel to operate gate chained and locked so gate operation could not be verified.10/31/2012 no cover; debris inside riser could prevent slide gate from closing. This crossing was listed in the USACE Periodic Inspections as ID# USACE_CESPK_MA07_2010_a_0060 however, no issues noted. (DWR UCIP - O. Magana)
FIELD_STRUCT_DESC: 2 of 2: 60-inch corrugated metal gravity drainage pipe through the levee, 12.5 feet below the crown. Slide gate in a 78-inch corrugated metal pipe (CMP) well on the waterside (WS) slope. Concrete bulkheads on both ends. Reinforced concrete spillway on the WS end. (Existing 60-inch corrugated metal gravity drainage pipe crossing remained during the Feather River West Levee Improvements, Project D). [Additional Reference(s): DWR Levee Log, 2005. USACE Sacramento O&M Manual 152, March 1957 (Station 1+90). Sutter Butte Flood Control Agency (SBFCA) Feather River West Levee Project, Volume 4 of 6 (Project D) Feather River West Levee Improvement Plans Sta 1765+00 to 2368+26, 2016, Volume 4-SBFCA_Record_Drawings_Project D_2017.05.16.pdf, Drawing No. C-101].

Overview of levee crown looking upstream towards crossings.

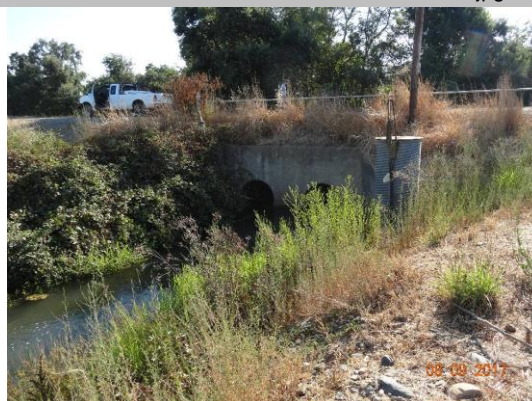
Photo 2 of 3 : UCIP_FA_2018_52389_77357.jpg

UCIP Comments: 08/09/2017 Dual 60-inch pipes are still present--no modifications appear to have been made to this structure. No permit or owner has been identified. Need to contact owner to notify of safety issue regarding the missing covers for CMP riser. (DWR UCIP - O. Magana)08/02/2017 After reviewing record drawings it appears this crossing has remained. Project Improvements begin at Station (Sta) 1765+00 (MA0007 about LM 1.73) to Sta 2303+50 (ST0005 about LM 1.23), refer to record drawings for the Feather River West Levee Improvement Plans Station 1765+00 to 2368+26, Project D details. MA0007 project details include NO CUTOFF WALL from Sta 1765+00 (MA0007 about LM 1.73) to 1815+00 (MA0007 about LM 2.64) and LEVEE DEGRADE AND RECONSTRUCTION WITH CUT OFF WALL from Sta 1817+00 (MA0007 about LM 2.69) to Sta 2289+00, Sta 2287+00 to Sta 2290+00 (MA0007 about LM 11.60). (DWR UCIP - O. Magana)

5/16/2016 Feather River West Levee Improvement Project--Levee currently under construction.6/10/2015 Debris still present inside riser and pipe was not replaced with the SBFC project.12/29/2014 Same as last inspection.5/19/2014 Same as last inspection.11/6/2013 Same as last inspection.5/13/2013 SBFC project recommends replacing in accordance with title 23.5/7/2013 Same as last inspection. Recommend constructing cover to prevent falls. Wheel to operate gate chained and locked so gate operation could not be verified.10/31/2012 no cover; debris inside riser could prevent slide gate from closing. This crossing was listed in the USACE Periodic Inspections as ID# USACE_CESPK_MA07_2010_a_0060 however, no issues noted. (DWR UCIP - O. Magana)

LS view: concrete headwall with dual 60-inch crossings.

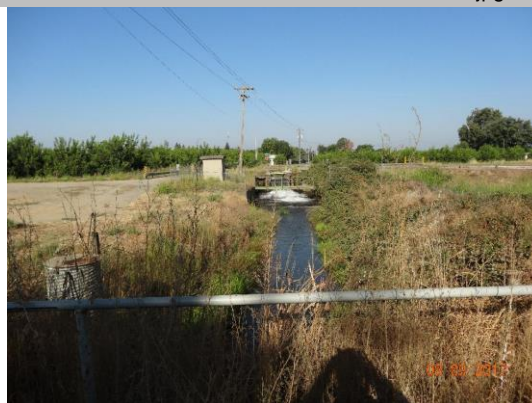
Photo 3 of 3 : UCIP_FA_2018_52389_77358.jpg

UCIP Comments: 08/09/2017 Dual 60-inch pipes are still present--no modifications appear to have been made to this structure. No permit or owner has been identified. Need to contact owner to notify of safety issue regarding the missing covers for CMP riser. (DWR UCIP - O. Magana)08/02/2017 After reviewing record drawings it appears this crossing has remained. Project Improvements begin at Station (Sta) 1765+00 (MA0007 about LM 1.73) to Sta 2303+50 (ST0005 about LM 1.23), refer to record drawings for the Feather River West Levee Improvement Plans Station 1765+00 to 2368+26, Project D details. MA0007 project details include NO CUTOFF WALL from Sta 1765+00 (MA0007 about LM 1.73) to 1815+00 (MA0007 about LM 2.64) and LEVEE DEGRADE AND RECONSTRUCTION WITH CUT OFF WALL from Sta 1817+00 (MA0007 about LM 2.69) to Sta 2289+00, Sta 2287+00 to Sta 2290+00 (MA0007 about LM 11.60). (DWR UCIP - O. Magana)

5/16/2016 Feather River West Levee Improvement Project--Levee currently under construction.6/10/2015 Debris still present inside riser and pipe was not replaced with the SBFCA project.12/29/2014 Same as last inspection.5/19/2014 Same as last inspection.11/6/2013 Same as last inspection.5/13/2013 SBFCA project recommends replacing in accordance with title 23.5/7/2013 Same as last inspection. Recommend constructing cover to prevent falls. Wheel to operate gate chained and locked so gate operation could not be verified.10/31/2012 no cover; debris inside riser could prevent slide gate from closing. This crossing was listed in the USACE Periodic Inspections as ID# USACE_CESPK_MA07_2010_a_0060 however, no issues noted. (DWR UCIP - O. Magana)

LS view: canal located on LS, photo taken from levee crown looking west.

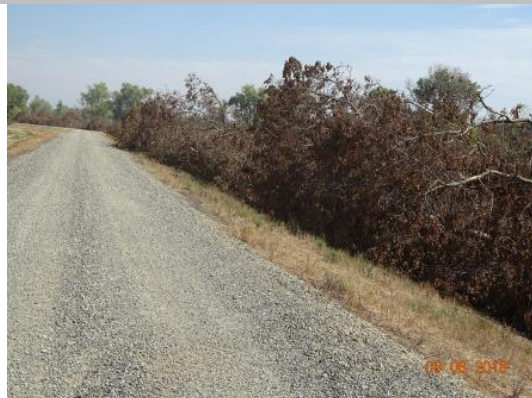
Photo 1 of 1 : FA_2018_MA0007_200_13_20181002_00029.jpg

LM Start	2.11	Rating **	U	Issue No.	13
LM End	2.27	Issue Type +	En	Location *	WS
Category	Earthen Levee			GPS Latitude/Longitude	
				Start	End
Item	Encroachments			39.339486 °	39.341623 °
				-121.631695 °	-121.630531 °
DWR ID	DWR_MA0007_01_f_2018_13				
Comment Code					
PR : Prunings					
Inspector Comment					
Remove the downed orchard trees from the levee slope, Fall 2018.

View looking upstream waterside where an orchard has been removed but the downed trees remain on the levee slope, Fall 2018.

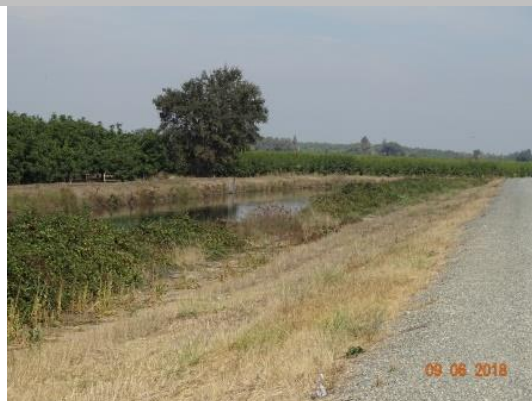
Photo 1 of 1 : FA_2018_MA0007_200_39_20181002_00030.jpg

LM Start	4.39	Rating **	M	Issue No.	39
LM End	5.35	Issue Type +	En	Location *	LS
Category	Earthen Levee			GPS Latitude/Longitude	
				Start	End
Item	Encroachments			39.366547 °	39.380071 °
				-121.647523 °	-121.650558 °
DWR ID	DWR_MA0007_01_s_2012_39				
Comment Code					
DT : Ditch					
Inspector Comment					
Landside irrigation ditch.

View looking upstream landside at an irrigation ditch at the levee toe, Fall 2018.

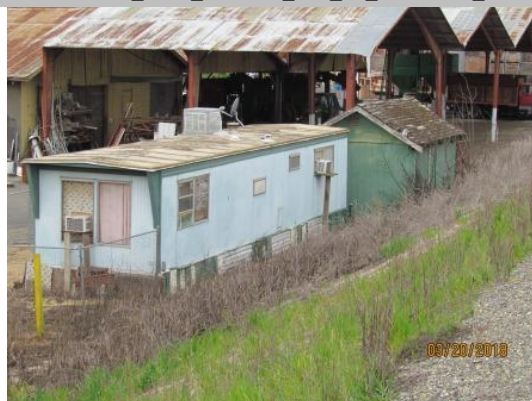
Photo 1 of 1 : FA_2018_MA0007_200_45_20180906_00004.jpg

This photo shows a building at the landside toe, no permit found.

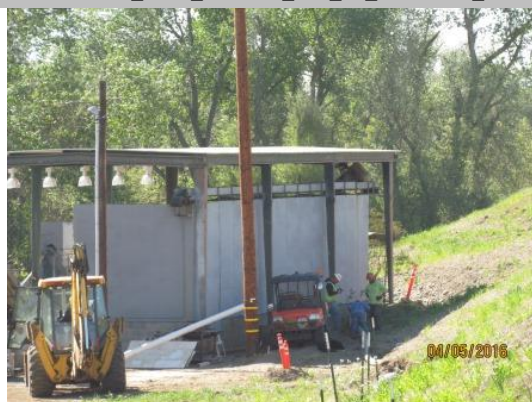
Photo 1 of 1 : FA_2018_MA0007_200_40_20180906_00003.jpg

View showing structure, waterside, looking downstream.
